LEAD REMEDIATION SCOPE OF WORK

Wayside Elementary School – HVAC Replacement
1000 Ming Avenue, Bakersfield, CA 93307

Kristy Yowell, CAC 09-4500 / CDPH 4640
YES Environmental, Inc. (YES, Inc.)
YES, Inc. Project Number 23YES-117
April 10, 2024

LEAD SCOPE OF WORK

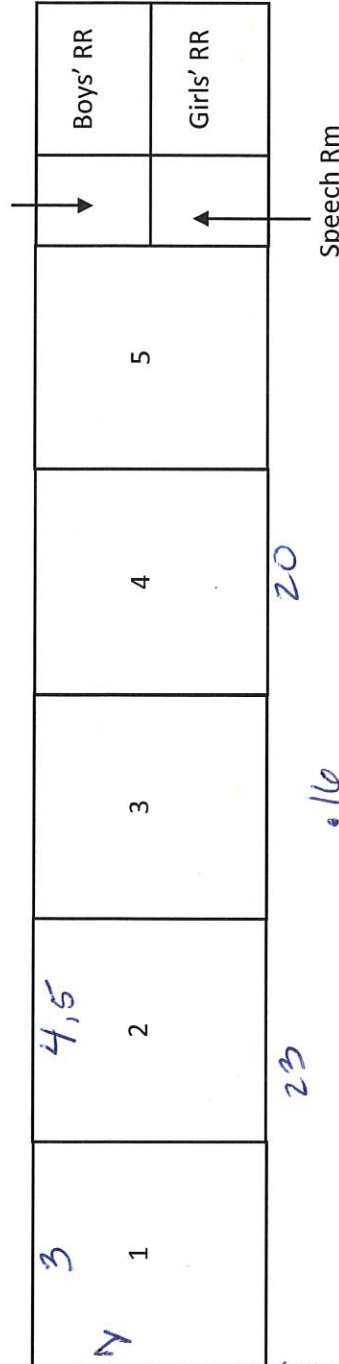
Building A

#'s = Line number on XRF report.

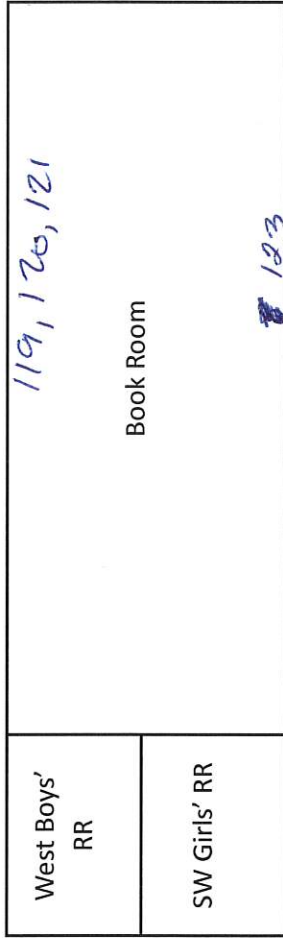
Building G

123

134, 124, 125

128, 131
