To: All Bidders
 Re: Abatement Projects: McKinley Elementary School Abatement, Flooring, Painting & Tackboard – Addendum No. 01

McKinley ES – Classrooms 40-43 & West Side Ancillary Rooms
601 4th Street, Bakersfield, CA 93304

McKinley ES – Rooms 14-18, 24-29, 34-43 & CCS Rooms
601 4th Street, Bakersfield, CA 93304

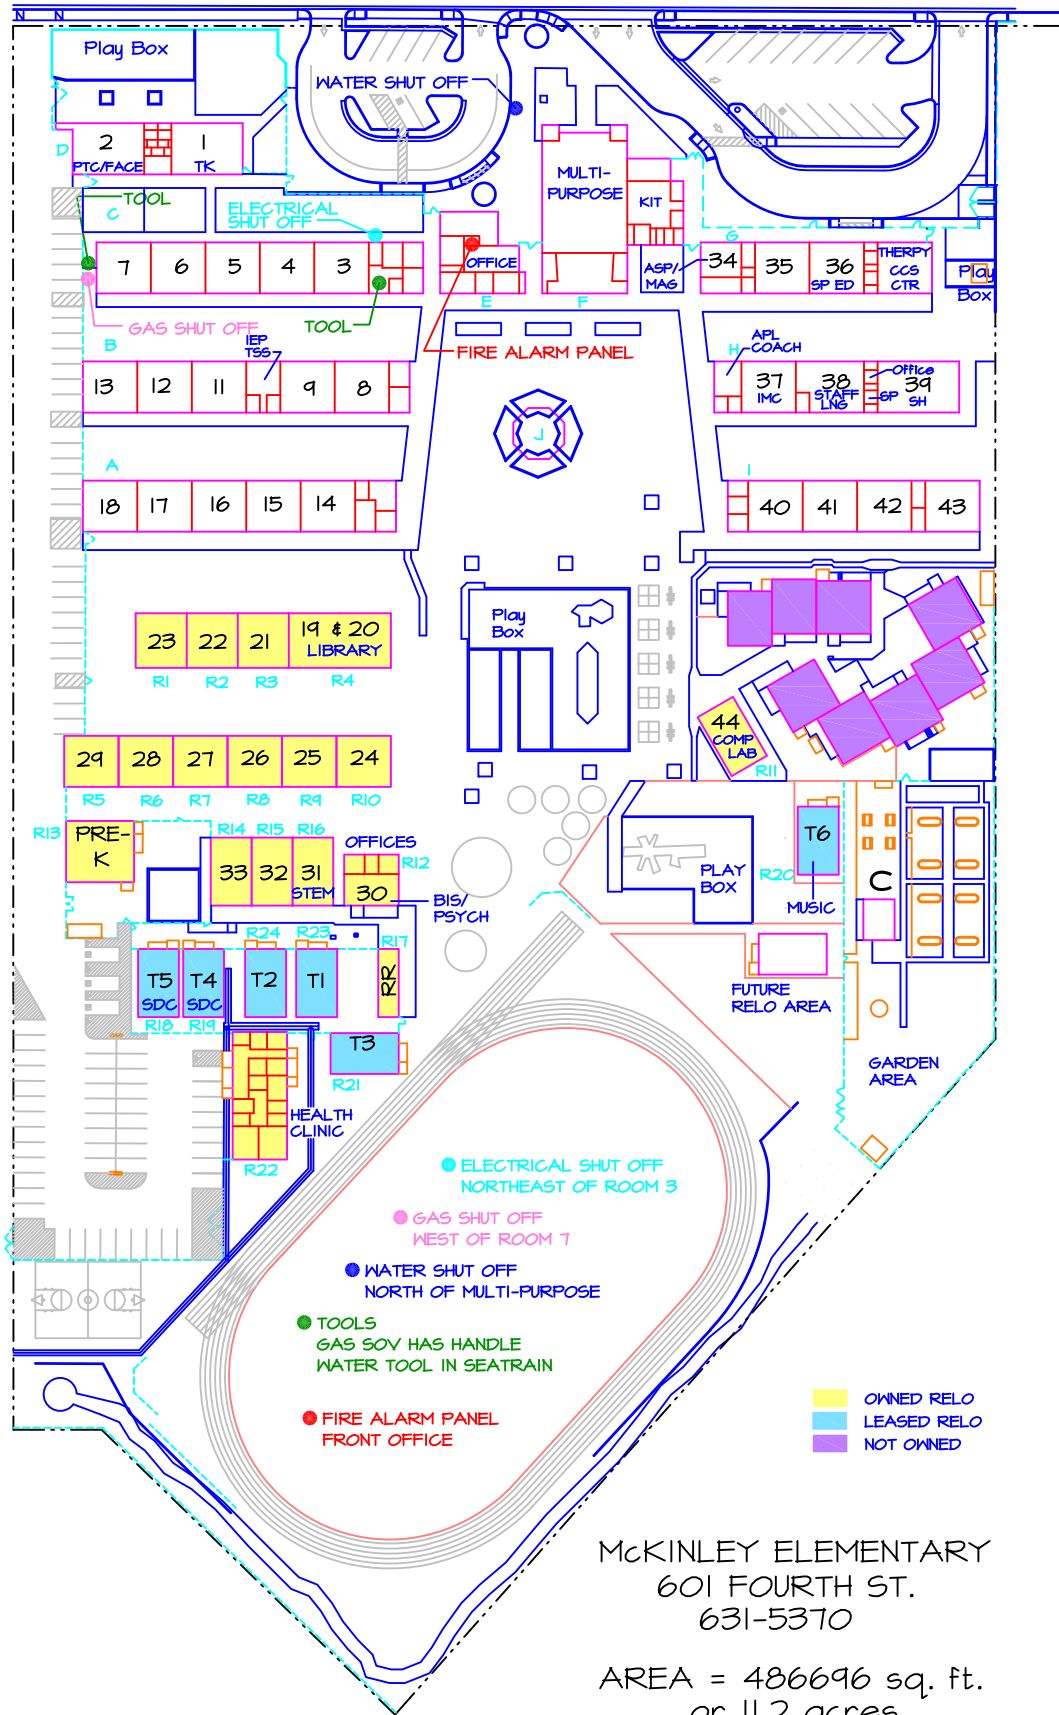
Attachment A – Site Map

McKINLEY ELEMENTARY
 601 FOURTH ST.
 631-5370

AREA = 486696 sq. ft.
 or 11.2 acres
