**PRE-RENOVATION
ASBESTOS SURVEY,
LEAD-BASED PAINT INSPECTION,
PCB & MERCURY SURVEY REPORT**

**MT. VERNON ELEMENTARY SCHOOL
2161 POTOMAC AVENUE
BAKERSFIELD, CALIFORNIA**

**SUBJECT: Pre-Renovation Asbestos Survey, Lead-Based Paint Inspection,
PCB & Mercury Survey Report
Mt. Vernon Elementary School
2161 Potomac Avenue
Bakersfield, California**

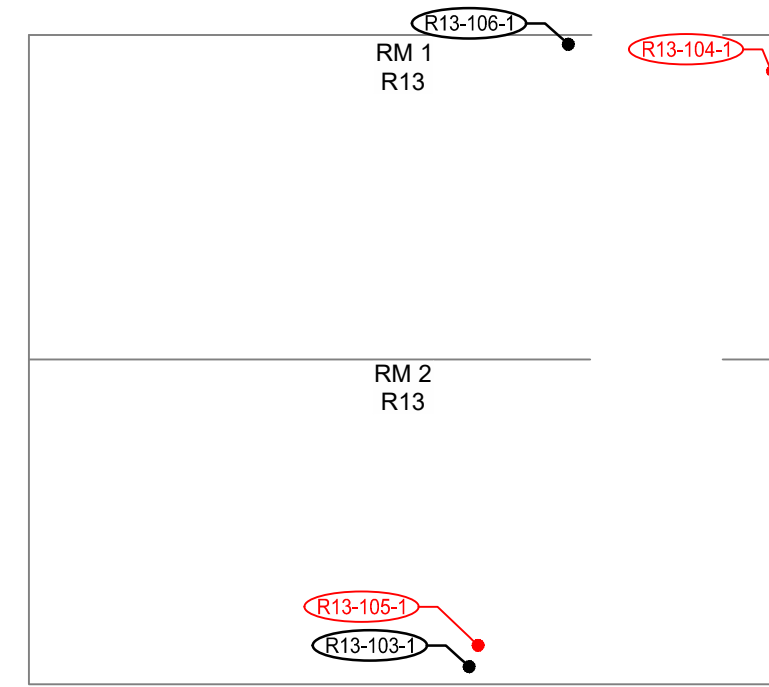
MT VERNON ELEMENTARY - BUILDING R13 & R30		DRAWN BY: JA
	2161 POTOMAC AVENUE BAKERSFIELD, CA		DATE: 2/8/2023
BAKERSFIELD CITY SCHOOL DISTRICT			JOB NO: 02854-22-001
			10 OF 14

- (A) DENOTES SIDE REFERENCE
- (###) DENOTES ASBESTOS SAMPLE LOCATION
- (###) DENOTES POSITIVE ASBESTOS SAMPLE LOCATION
- XRF-## DENOTES POSITIVE LEAD SAMPLE LOCATION
