ASBESTOS ABATEMENT SCOPE OF WORK

Wayside Elementary School – HVAC Replacement
1000 Ming Avenue, Bakersfield, CA 93307

ASBESTOS SCOPE OF WORK

Wayside Elementary School – HVAC Replacement

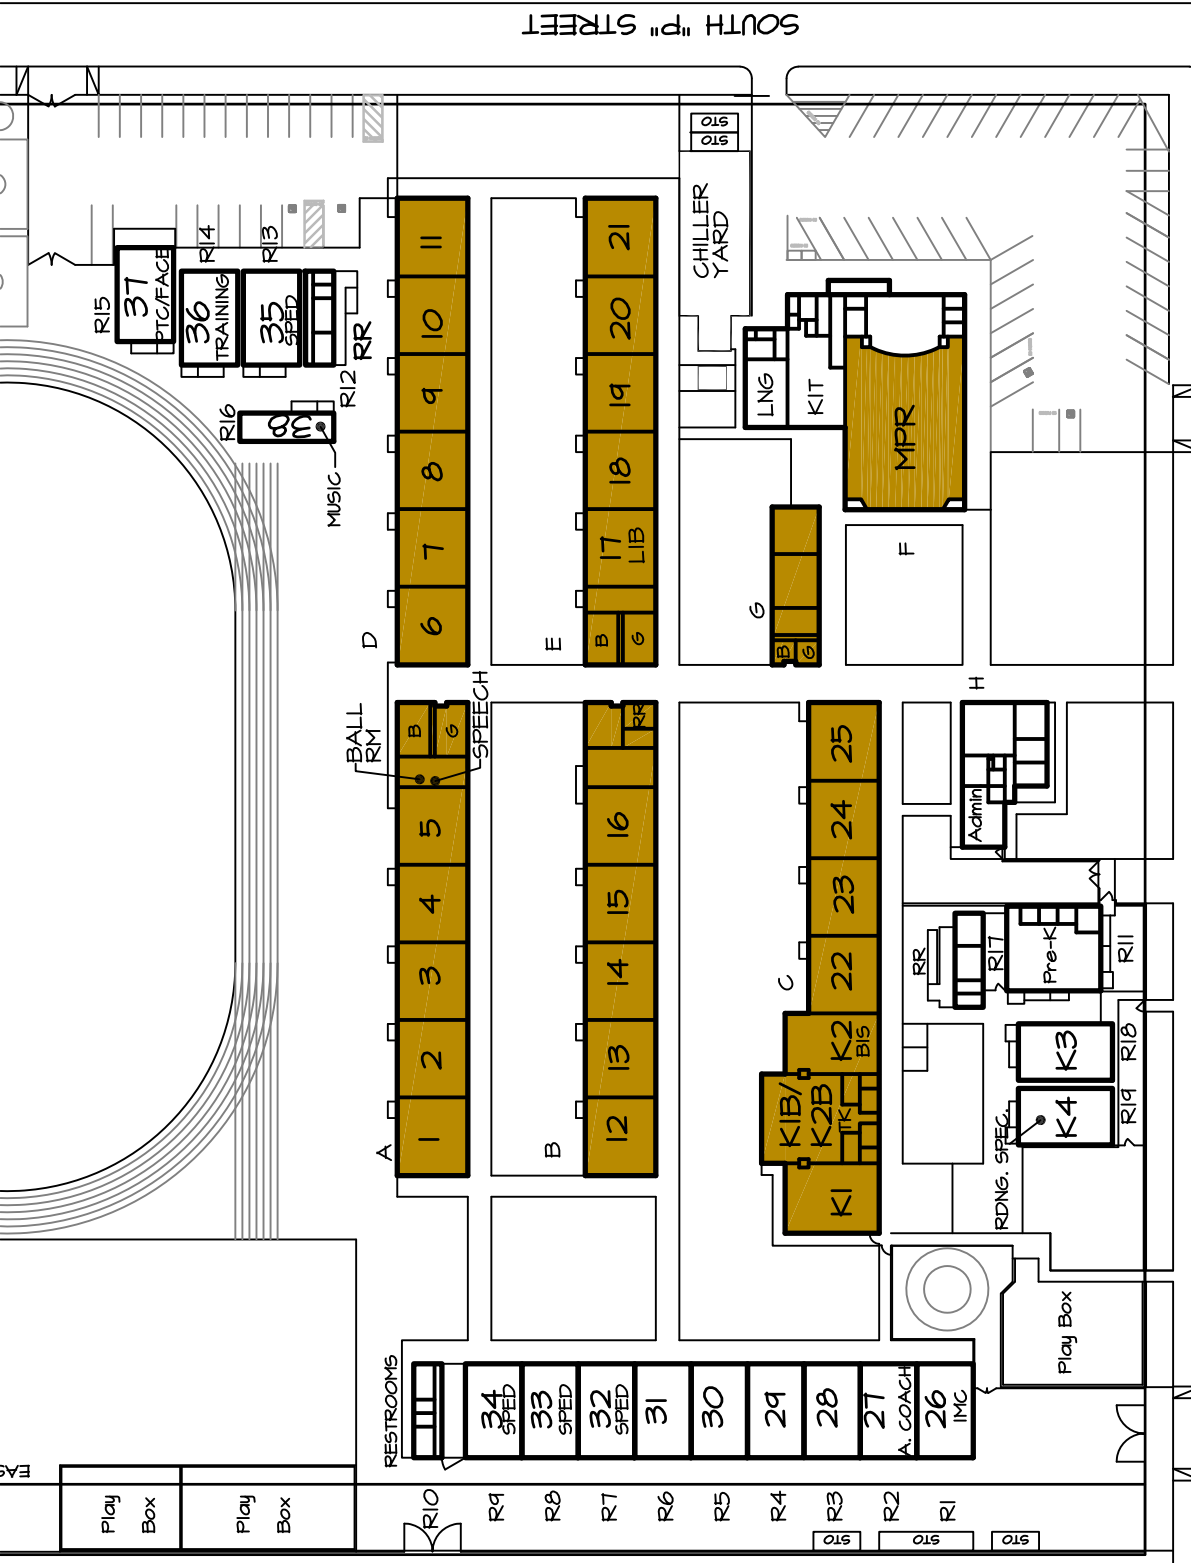
Attachment A – Site & Building Maps

■ REMOVE PERMANENT ROOMS FROM CHILLER SYSTEM. INSTALL NEW INDIVIDUAL WALL OR ROOF UNIT

WAYSIDE ELEMENTARY SCHOOL
1000 MING AVE.
