To: All Bidders
Re: Abatement Projects: Munsey Elementary School Abatement, Flooring & Painting – Addendum No. 01

ASBESTOS ABATEMENT SCOPE OF WORK

Munsey ES – Portable T1, 11A North RR & 11A South RR
3801 Brave Avenue, Bakersfield, CA 93309

ASBESTOS FLOORING ABATEMENT SCOPE OF WORK Munsey ES – Portable T1, 11A North Restroom & 11A South Restroom

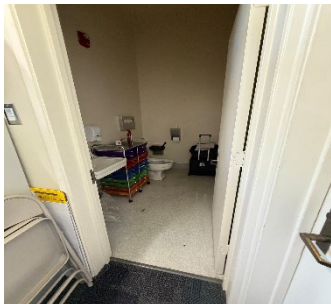
Material Description	Location(s) See attached map for room locations	% Asbestos	Approximate Quantity	NESHAP Category
<p>Concealed 9" floor tile & black mastic</p> <p>Sample #: 01A-01B</p>	<p>11A South & 11B North Staff Restrooms</p> <ul style="list-style-type: none"> - Flooring throughout both rooms (under the linoleum)

<p>Tile=2-3% CH Mastic=3% CH</p>	+/- 96 ft ²	RACM
<p>Grey mosaic linoleum & yellow glue</p> <p>Sample #: 02A-02B</p>	<p>11A South & 11B North Staff Restrooms</p> <ul style="list-style-type: none"> - Surface layer flooring & wall base throughout <p>NOTE: ACM floor tile beneath</p>	No asbestos detected	+/- 96 ft ²	N/A
<p>Concealed 9" green floor tile, black mastic & black felt</p> <p>Sample #: 04A-04B</p>	<p>Classroom T1</p> <ul style="list-style-type: none"> - Flooring throughout all the rooms (under carpet & 12" floor tile)

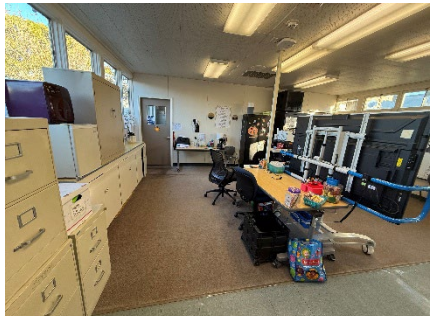
<p>Tile=3% CH Mastic=3% CH Felt=10% CH</p>	+/- 860 ft ²	RACM
